Customer : Stencil Customer  
PO Number :  
Image Nr. : withscanner

Operator : Laser Operator  
Date : 2/10/2009

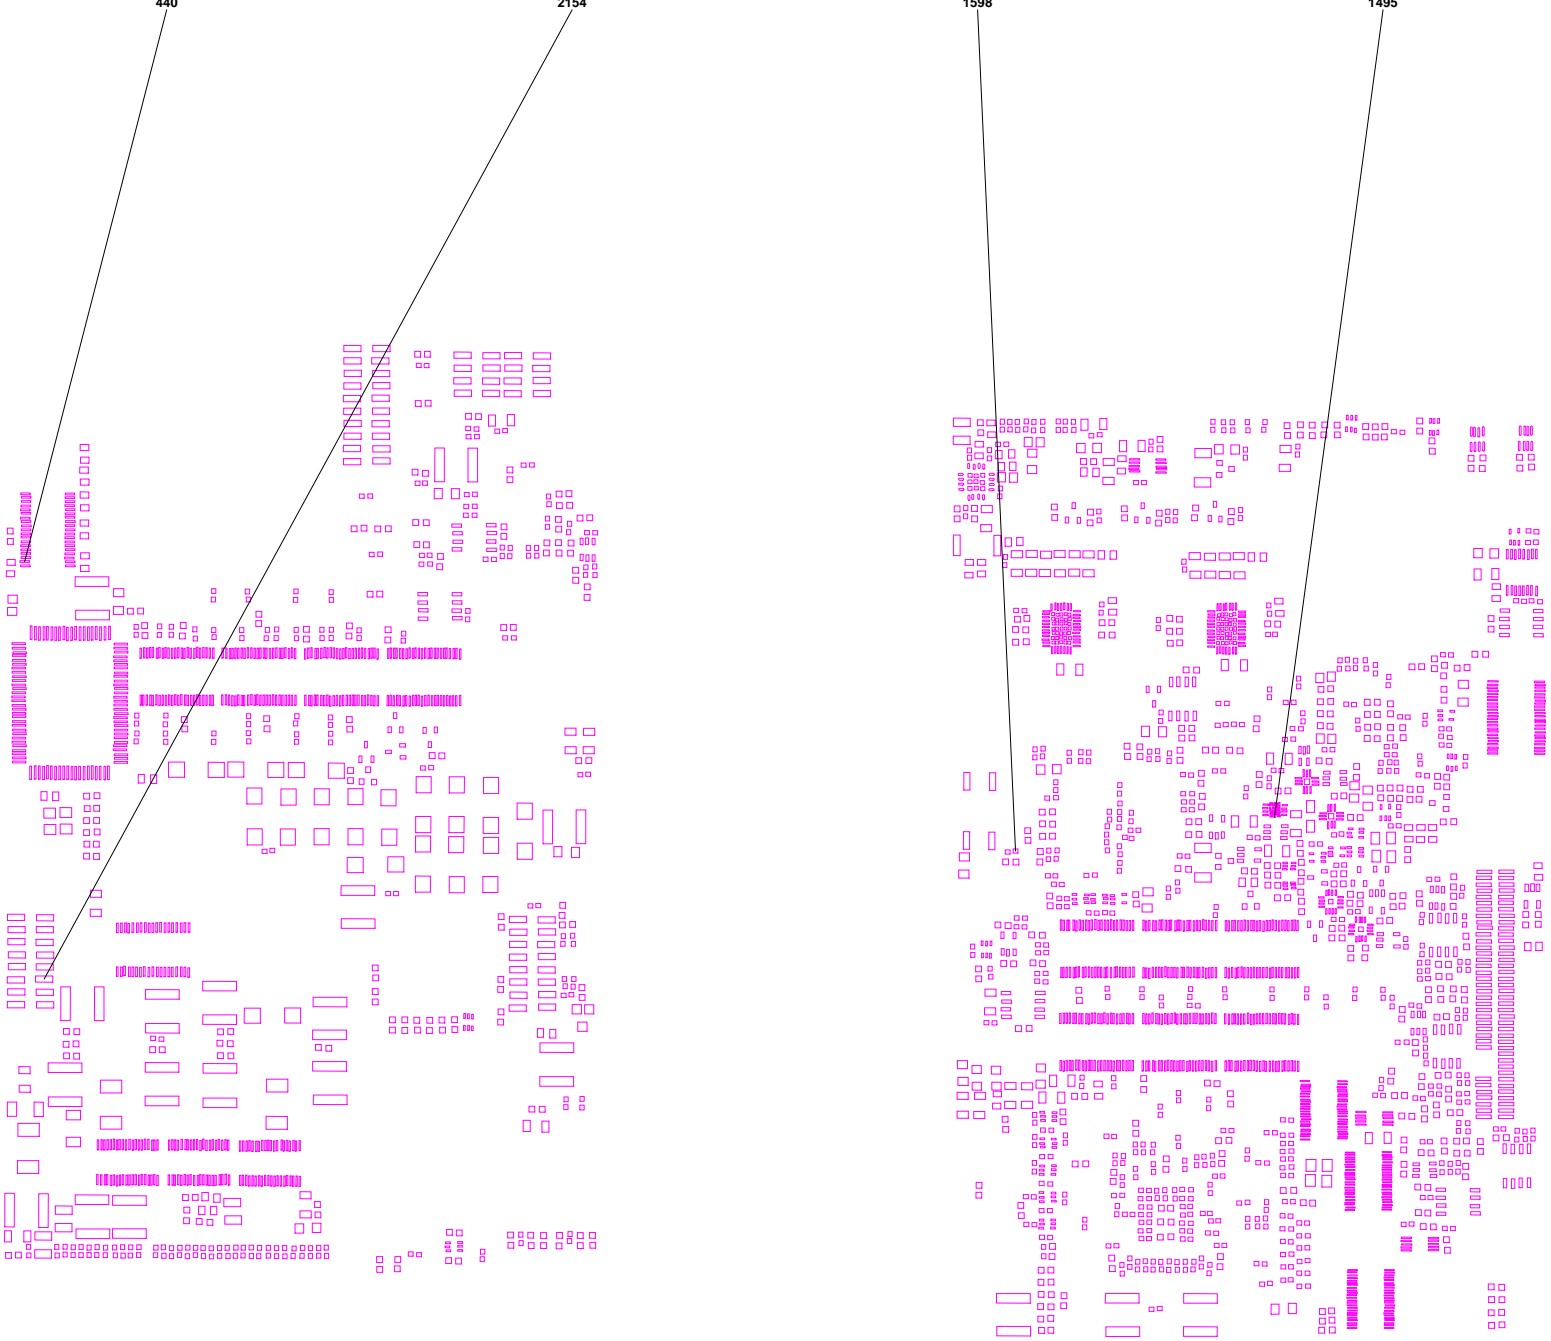
Verification Tolerances:

- 1. Presence - Max. Size: 0.20000 mm<sup>2</sup>
  - 2. Absence - Min. Size: 10.0 % of Orig. Size
  - 3. Position - X: 0.025 mm  
Position - Y: 0.025 mm
  - 4. Size: 95.00-105.00%
- Thickness: 0.125 mm

Verified Apertures: 3407

- 1. Presence Errors: 1475
- 2. Absence Errors: 0
- 3. Position Errors: 3056
  - Max. Position Error: 0.245 mm - Pad # 2154
  - Max. Position Error - X: -0.231 mm - Pad # 440
  - Max. Position Error - Y: -0.161 mm - Pad # 1598
- 4. Size Errors: 2245
  - Max. Area Error: 161.1 % - Pad # 1495

440

2154

1598

1495
